Rehabilitation of Historical Steel Bridge No. 321 over Rio Grande de Manatí

ACT Contract No. 668504

Puente Mata de Plátano / Ing. Juan José Jiménez

March 31, 2017
Alvin Rodríguez, PE
Elvin Pérez, PE

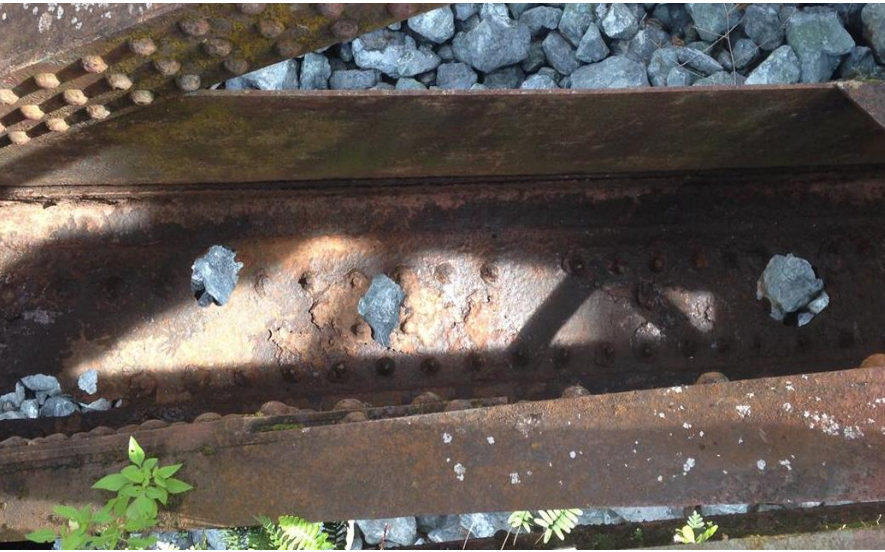
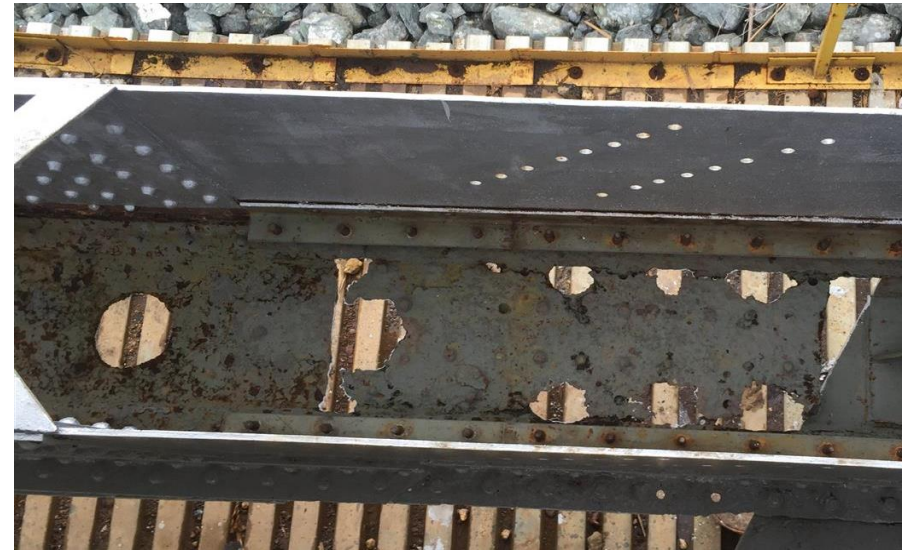
❑ Bottom Chords (Tension Element) - HS-15

- Perforation at bottom flange plate (Approx. 35% corrosion)
- Missing rivets
- Bottom chord to Vertical flange plate corrosion

RF = 0.50 (Inventory)
RF = 2.90 (Operating)

Element will need to be reinforced to **Add Capacity**

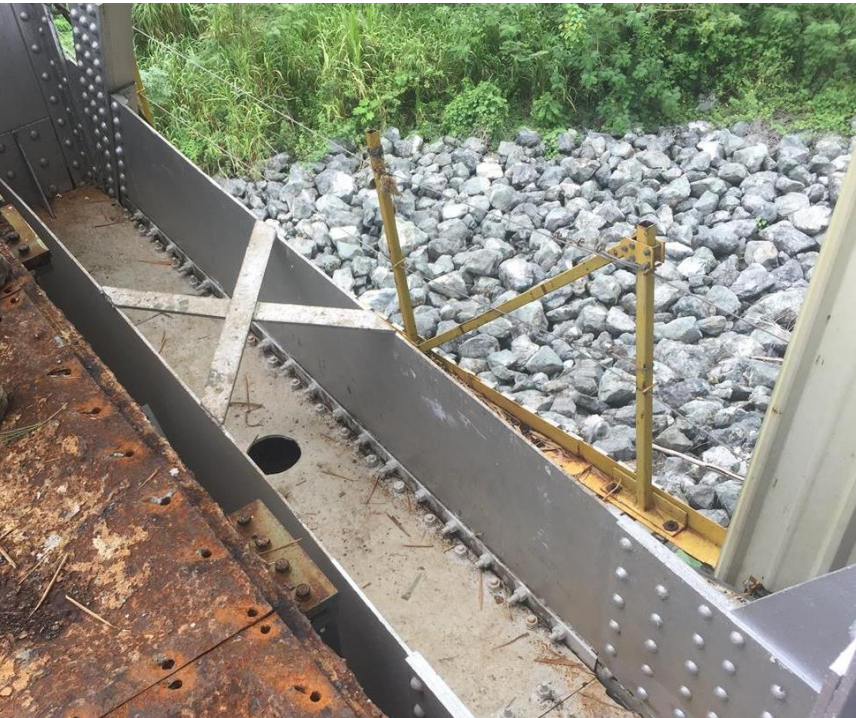
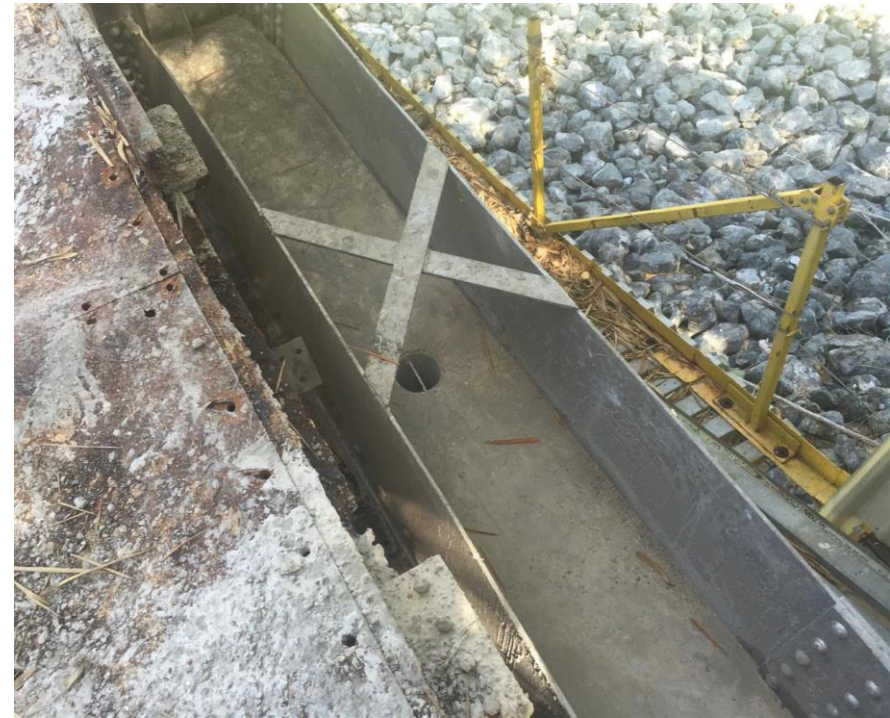
❑ Bottom Chords (Tension Element) – HS-15

RF = 3.84 (Inventory)
RF = 7.46 (Operating)

- Additional plate added for Capacity
- Concrete added to provide drainage slopes

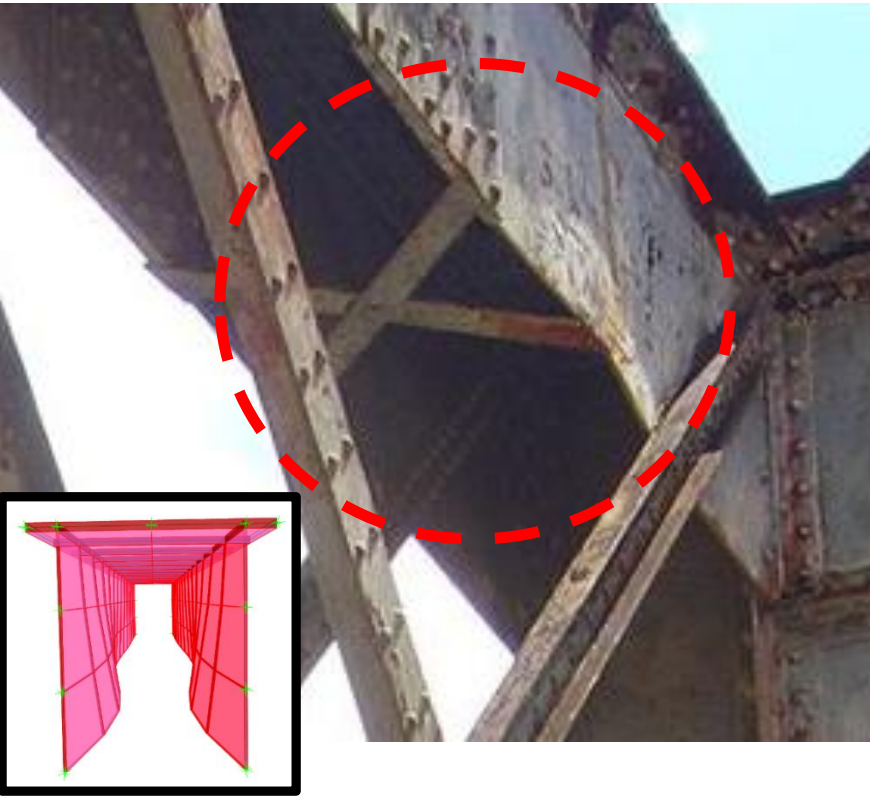
❑ Top Chords (Compression Element) – HS-15

- Top chord flange buckling
- Loss of section observed

RF = 0.57 (Inventory)
RF = 0.59 (Operating)

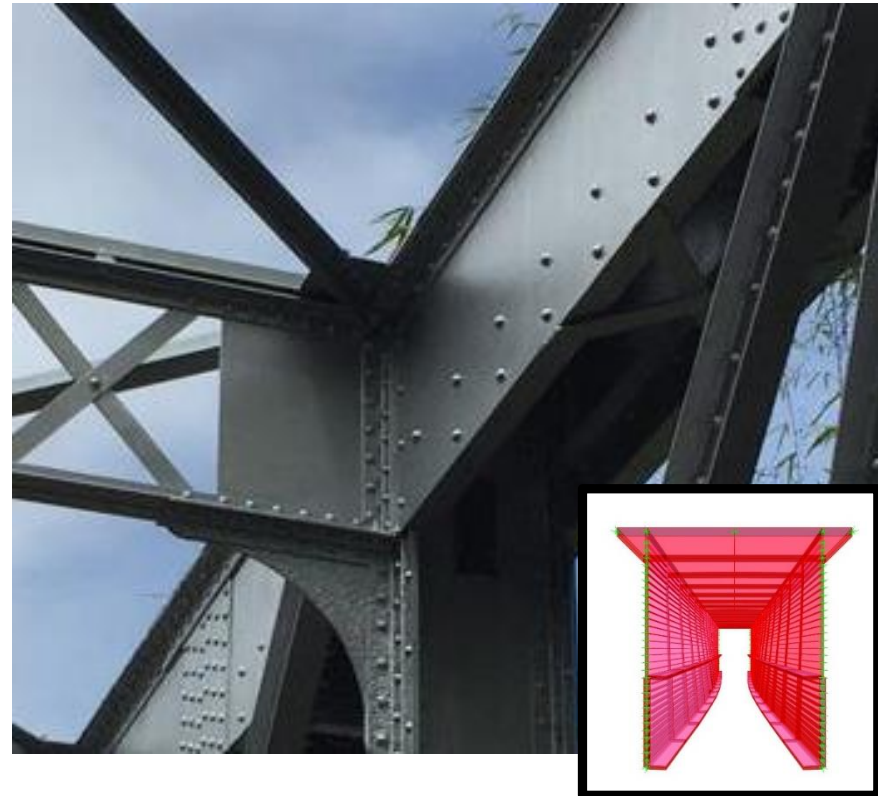
RF = 7.50 (Inventory)
RF = 6.94 (Operating)

- Added new C12x30 channels each side for stiffness

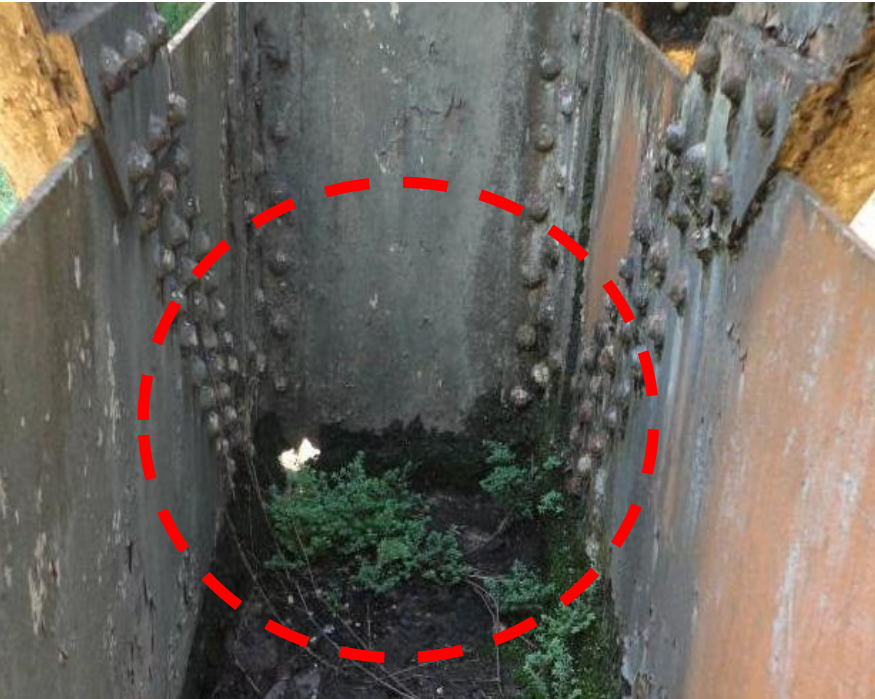
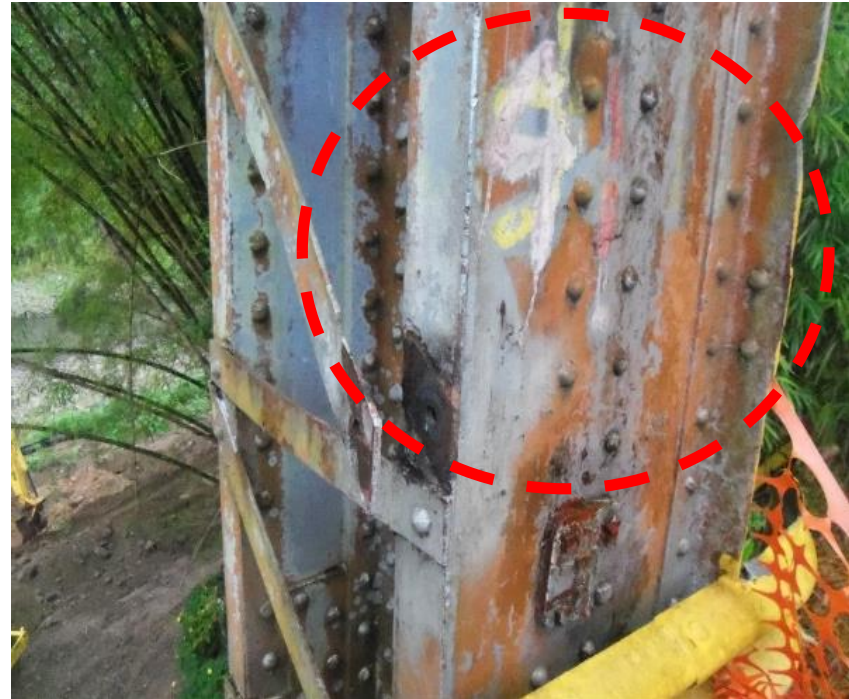
❑ East & West Truss Verticals – HS-15

- Severe Corrosion at bottom chord
- Missing rivets
- Deformation/bends at column flanges

RF = 7.07 (Inventory)
RF = 9.92 (Operating)

Element will need to be
Repair/Rehabilitated

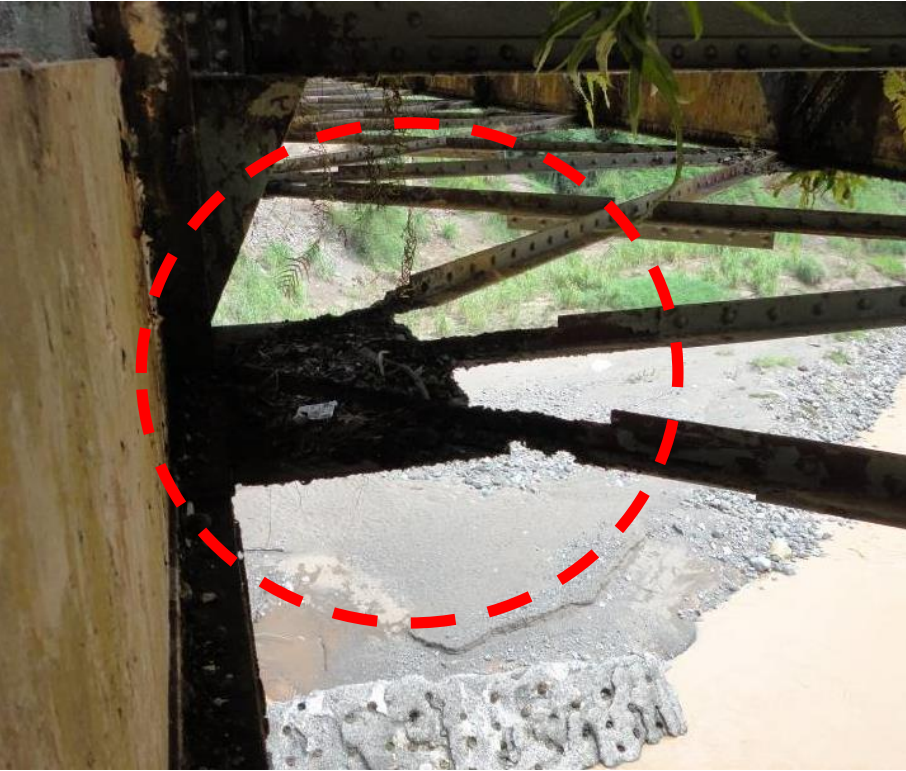
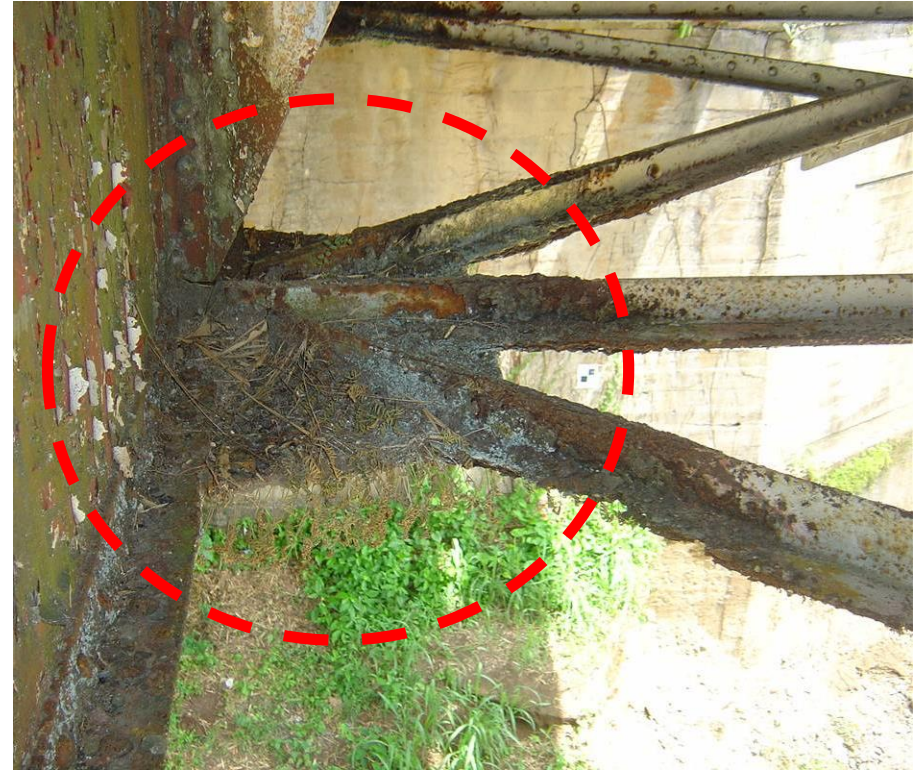
❑ Horizontal Bottom Truss Diagonals

- Bottom truss with severe corrosion at angles and gusset plates
- Areas with significant loss of section
- Connection to column is compromised

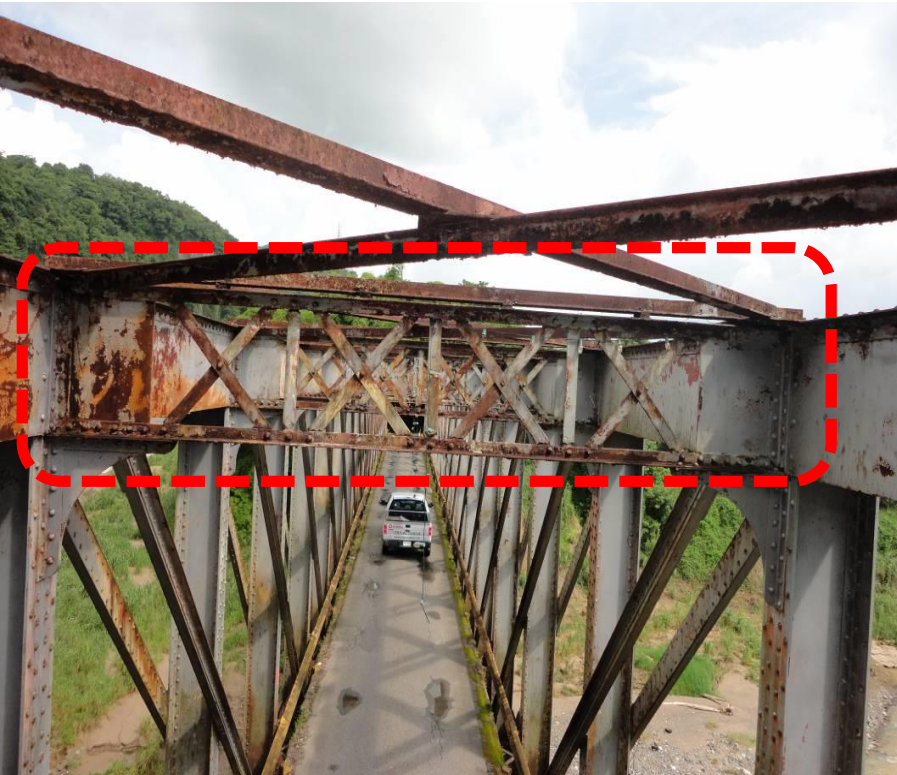
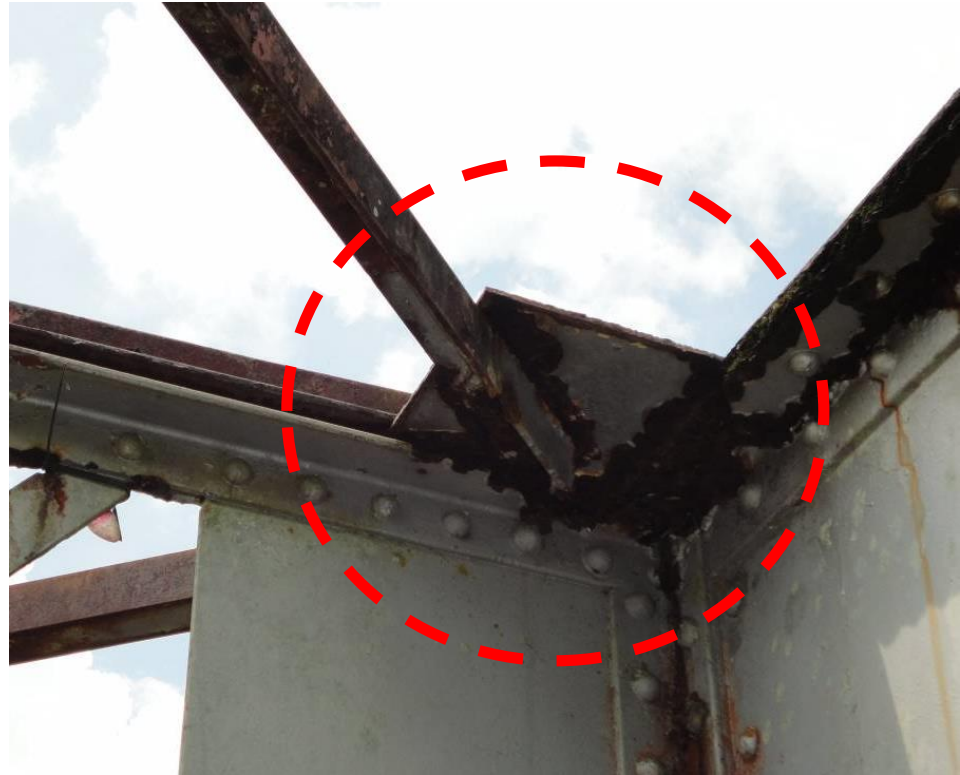
❑ Horizontal Top Truss Diagonals

- Top truss with severe corrosion at angles & gusset plates
- Local areas with significant loss of section

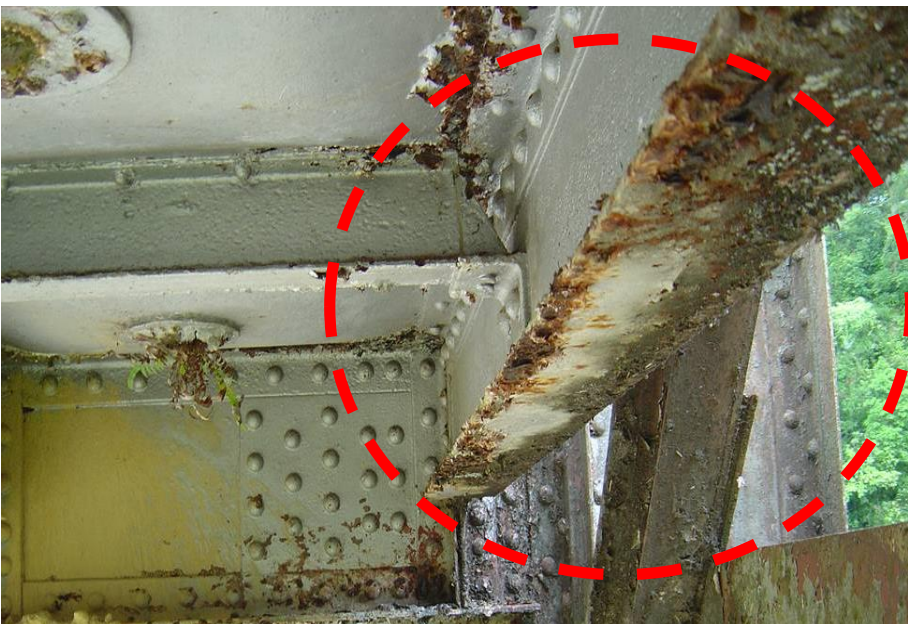
□ Deck & Supporting Beam - (HS-15)

- Moderate underside corrosion
- Local areas with significant loss of section

RF = 1.40 (Inventory)
RF = 2.30 (Operating)

Element will need to be
Repair/Rehabilitated

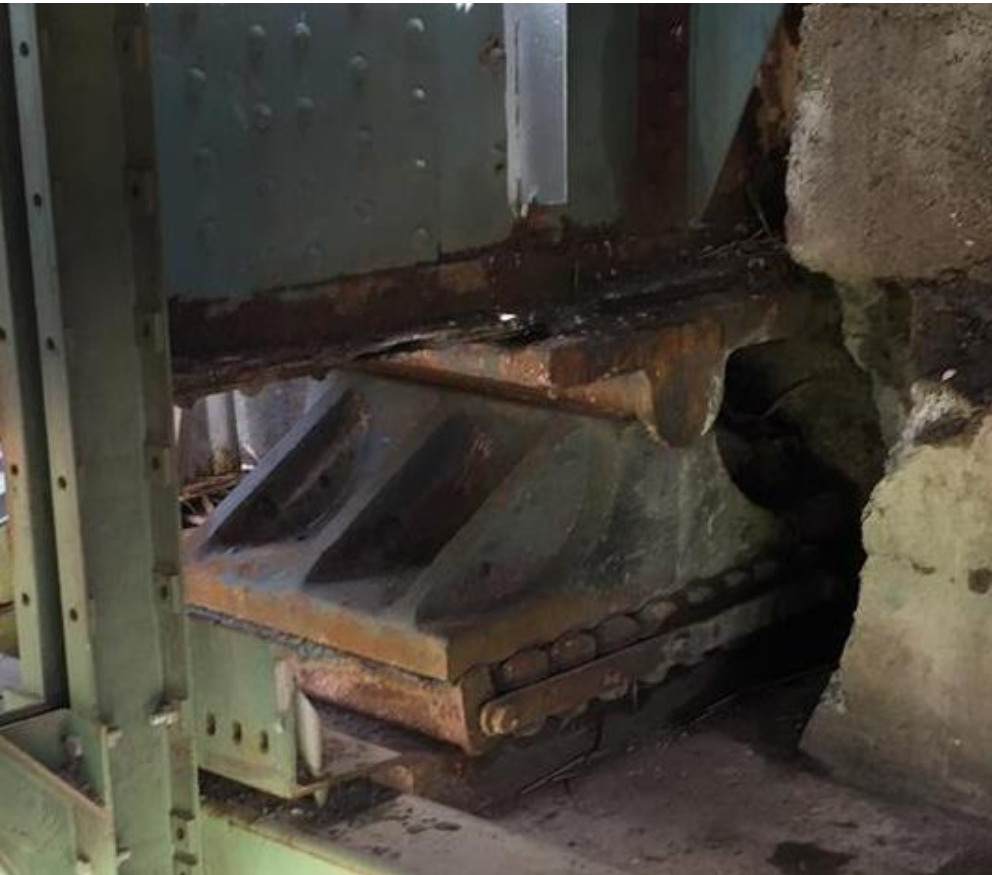
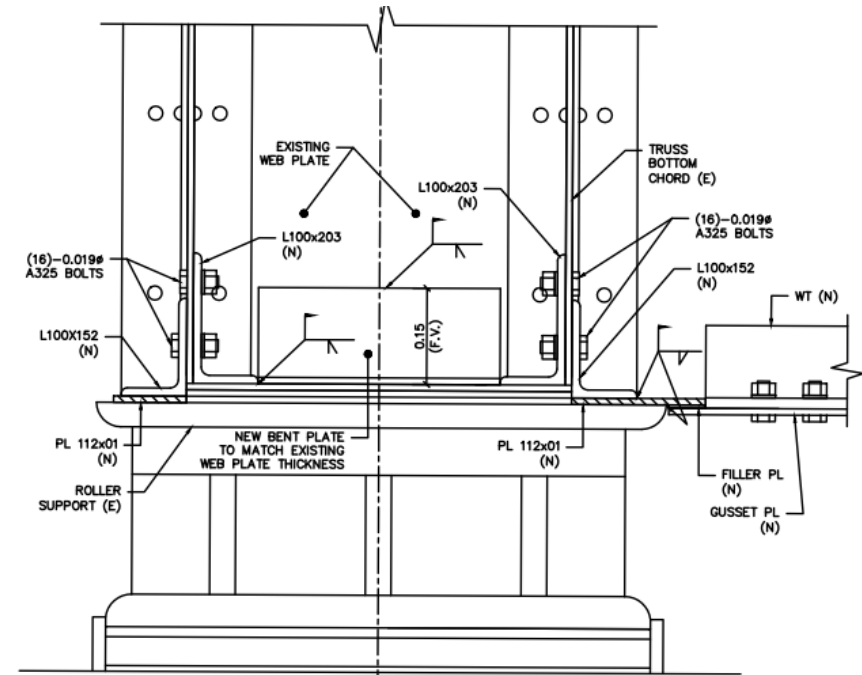
❑ Abutment

- Moderate corrosion at beam connection to roller
- Free sliding inhibited due to rust

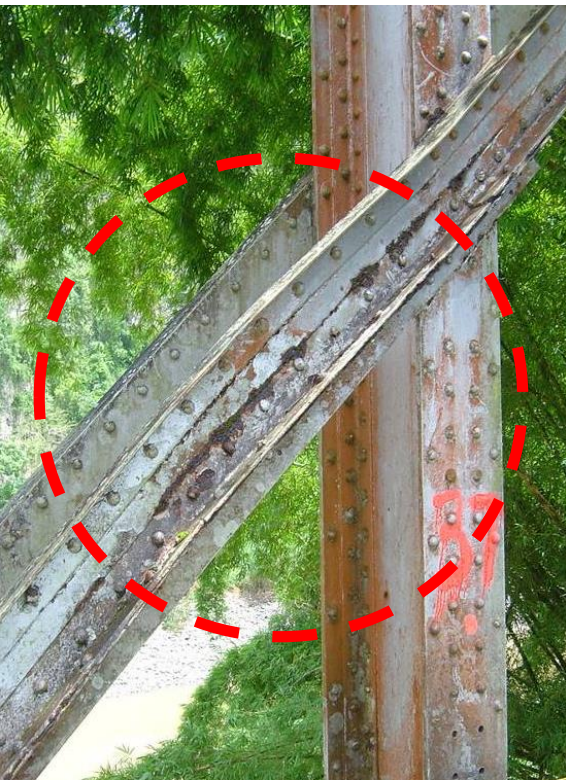
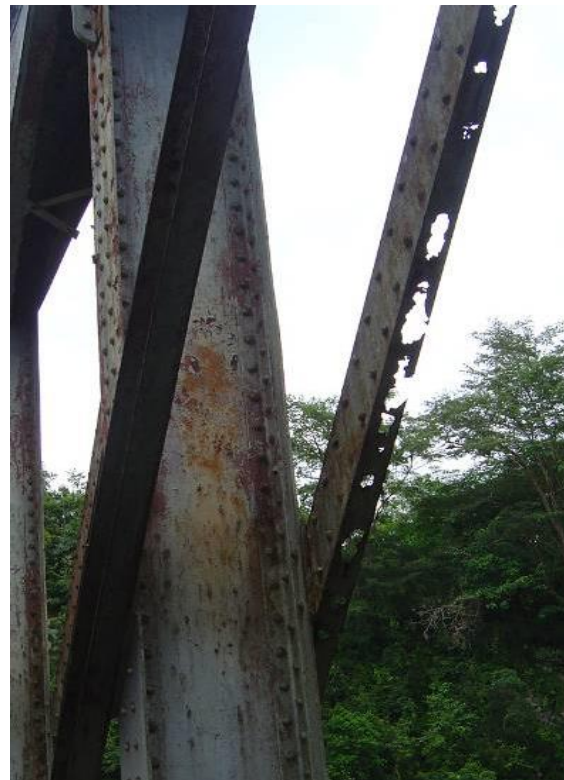
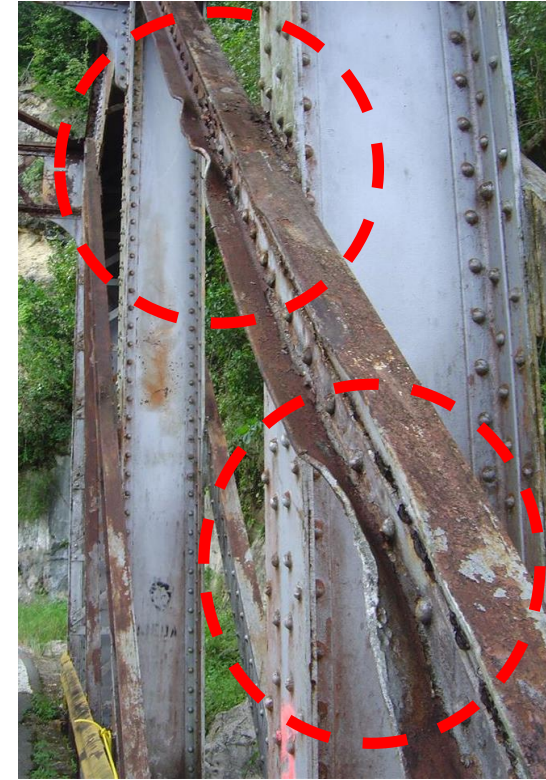
❑ East & West Truss Diagonals - (HS-15)

- Flange deformation/bends
- Significant corrosion

RF = 3.29 (Inventory)
RF = 6.88 (Operating)

Element will need to be
Repair/Rehabilitated
