Rehabilitation of Historical Steel Bridge No. 321 over Rio Grande de Manatí

ACT Contract No. 668504

Puente Mata de Plátano / Ing. Juan José Jiménez

March 31, 2017
Alvin Rodríguez, PE
Elvin Pérez, PE

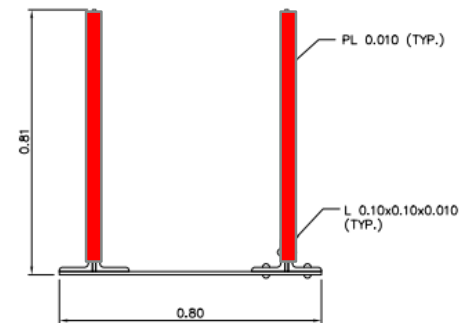
- Perforation at bottom flange plate (Approx. 35% corrosion)
- Missing rivets
- Bottom chord to Vertical flange plate corrosion

RF = 0.50 (Inventory)
RF = 2.90 (Operating)

Element will need to be reinforced to **Add Capacity**

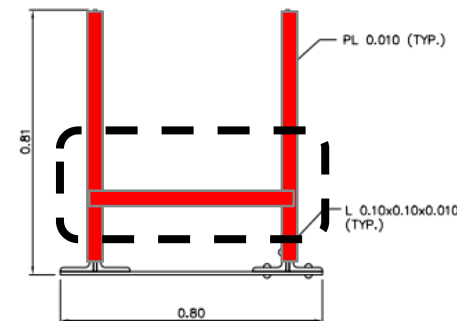
- Additional plate added for Capacity
- Concrete added to provide drainage slopes

RF = 3.84 (Inventory)
RF = 7.46 (Operating)

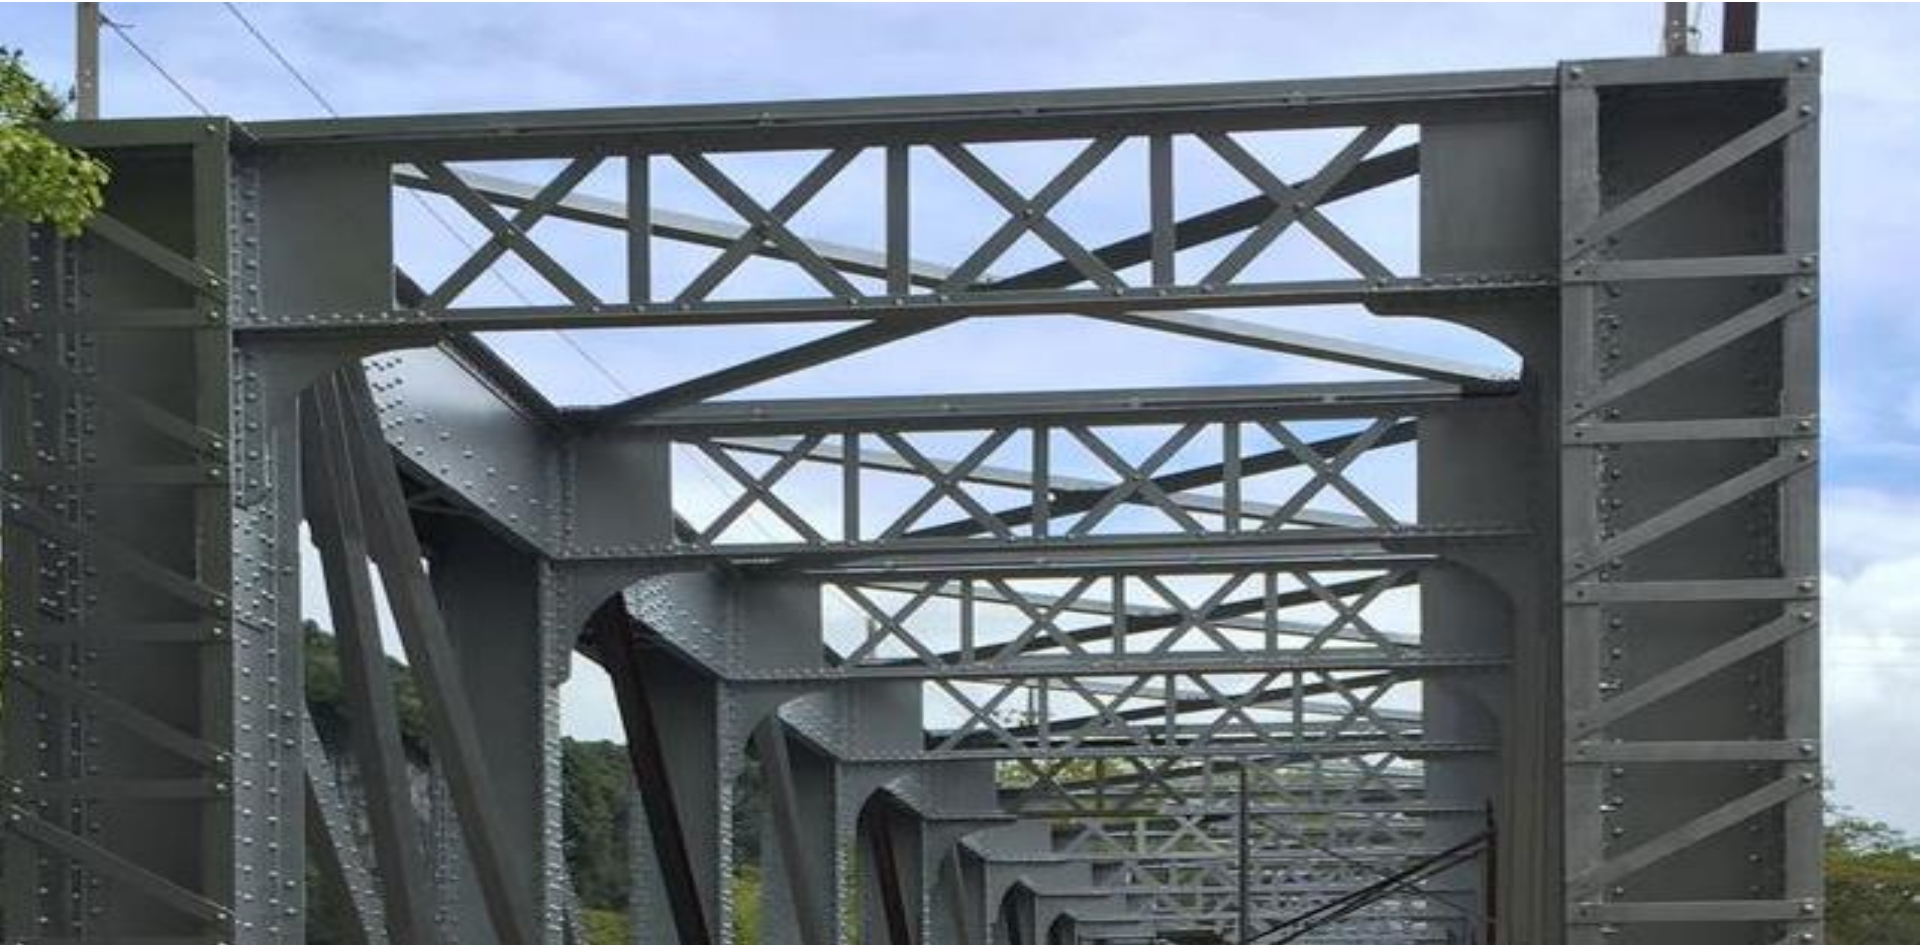
- ❑ Horizontal Top Truss Diagonals

- Top truss with severe corrosion at angles & gusset plates
- Local areas with significant loss of section

- Replace top cross-beam
- Replace horizontal truss diagonals

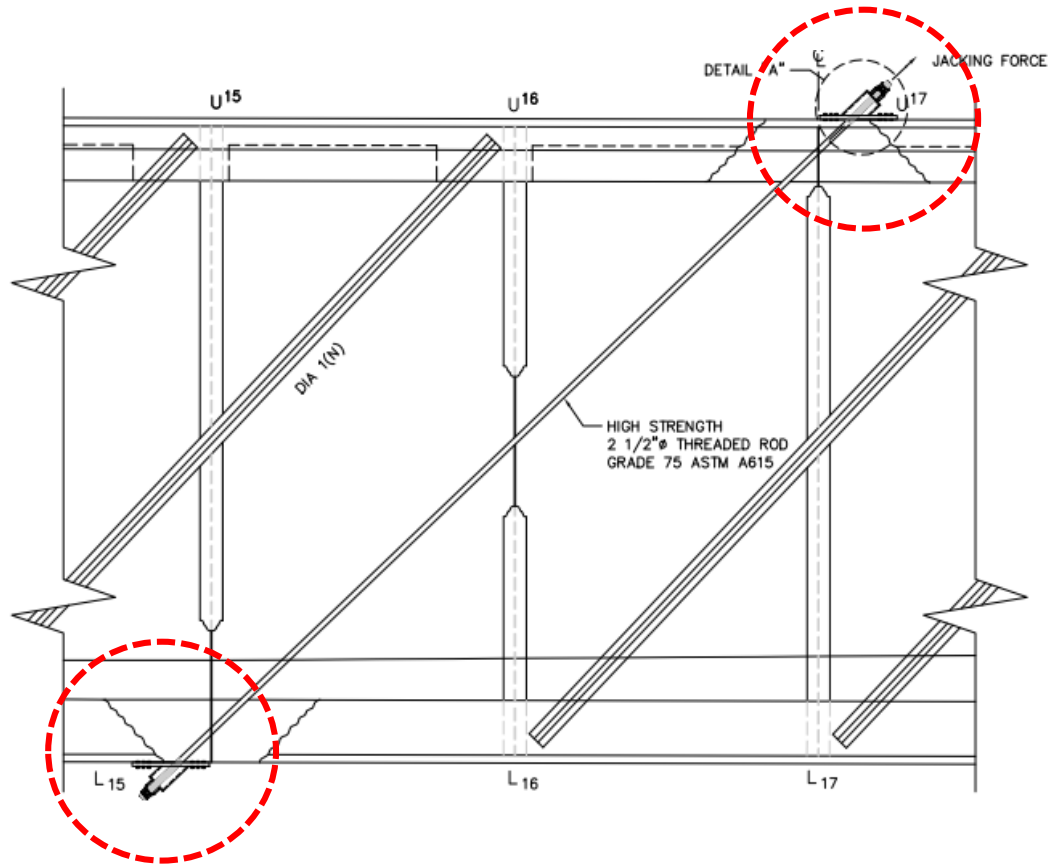
Dead-End Jacking Force System

- Readily available equipment (Hydraulic jack, electric pump)
- Area accessibility

U-11 - L-9	3.35 kips
U-13 - L-11	58.52 kips
U-17 - L-15	142.96 kips
U-19 - L-17	177.90 kips
U-20 - L-18	251.12 kips

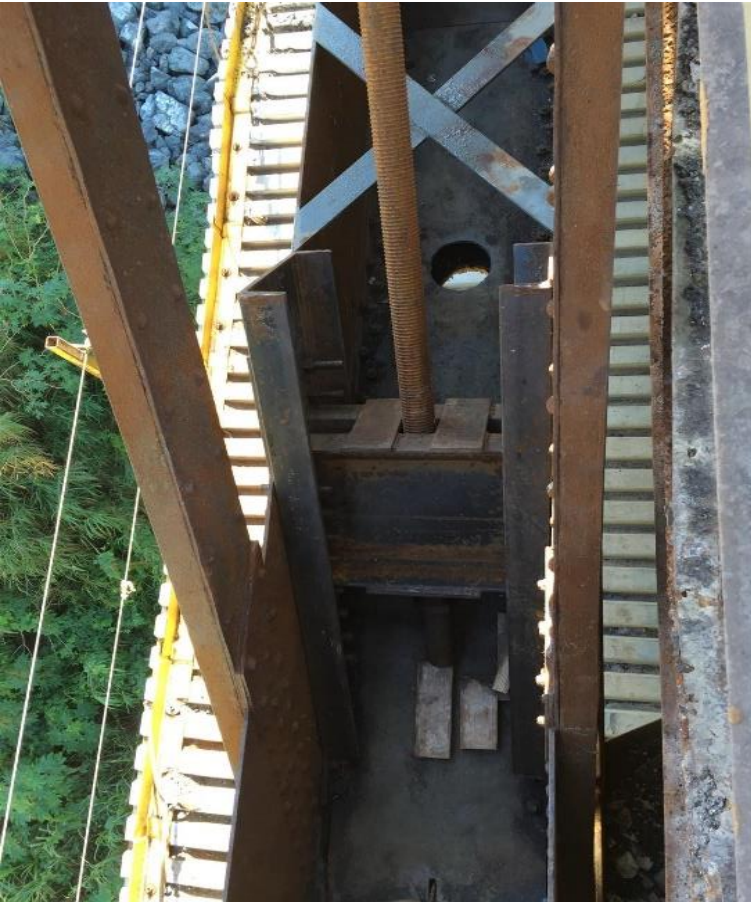
Bottom Chord
Dead End Jack

Weight = 400 lbs.
